DEPARTMENT OF TRANSPORTATION**DIVISION OF ENGINEERING SERVICES**

Quality Assurance and Source Inspection

Contract #: 04-0120F4Cty: SF/ALA Rte: 80 PM: 13.2/13.9File #: 69.28**WELDING INSPECTION REPORT****Resident Engineer:**Siegenthaler, Peter**Address:** 333 Burma Road**City:** Oakland, CA 94607**Report No:** WIR-021498**Date Inspected:** 06-Mar-2011**Project Name:** SAS Superstructure**OSM Arrival Time:** 700**Prime Contractor:** American Bridge/Fluor Enterprises, a JV**OSM Departure Time:** 1900**Contractor:** Zhenhua Port Machinery Company, Ltd (ZPMC), Changxing Island **Location:** Shanghai, China**CWI Name:** Li Yang**CWI Present:** Yes No**Inspected CWI report:** Yes No N/A**Rod Oven in Use:** Yes No N/A**Electrode to specification:** Yes No N/A**Weld Procedures Followed:** Yes No N/A**Qualified Welders:** Yes No N/A**Verified Joint Fit-up:** Yes No N/A**Approved Drawings:** Yes No N/A**Approved WPS:** Yes No N/A**Delayed / Cancelled:** Yes No N/A**Bridge No:** 34-0006**Component:** OBG Segments**Summary of Items Observed:**

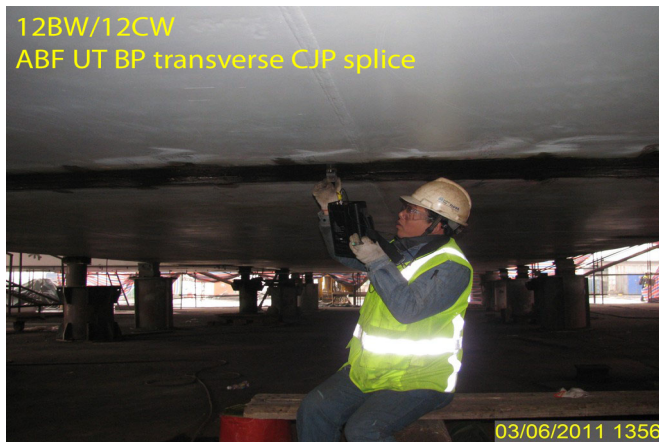
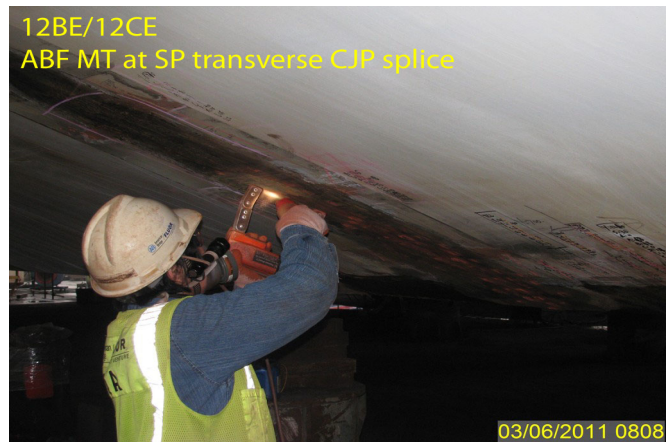
This QA Inspector observed Shielded Metal Arc Welding (SMAW) in progress of a fillet weld joint. The Weld joint is designated SEG3001Y-020, 021, Deck Plate I-rib hold back weld. The welder is identified as #200113 and was observed welding in the 4F(overhead) position using approved Welding Procedure Specification WPS-B-P-2114-FCM-1.

This QA Inspector observed Shielded Metal Arc Welding (SMAW) in progress of a fillet weld joint. The Weld joint is designated SEG3001Y-027, 028, Deck Plate I-rib hold back weld. The welder is identified as #067656 and was observed welding in the 4F(overhead) position using approved Welding Procedure Specification WPS-B-P-2114-FCM-1.

This QA Inspector observed ABF personnel performing Magnetic Particle Testing on the Side Plate transverse splice, cross beam and bike path side.

This QA Inspector observed ABF personnel performing Ultrasonic Testing on the Side Plate transverse splice, cross beam side.

This QA Inspector observed ABF personnel performing Ultrasonic Testing on the Bottom Plate transverse splice.

This QA Inspector observed ABF personnel performing Ultrasonic Testing on the Bottom Plate to Side Plate hold back weld, cross beam side at the east end of the segment.
